Manhole Inspection Summary

Manhole # S33MM_017MH

Insp Date: **11/29/06 1:26 PM**

Location Address: **2201 CHARLES ST**

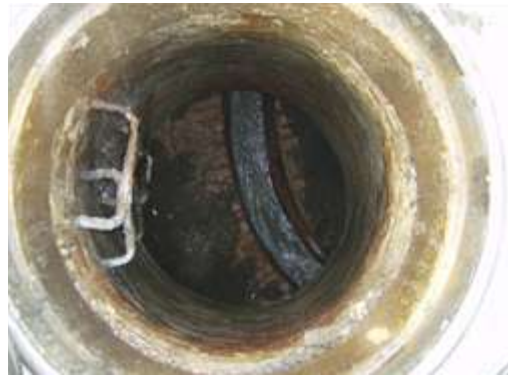
Top View

Frame leaks. Frame offset. Adjustment deterioration and infiltration. Barrel infiltration. Corroded steps. Evidence of

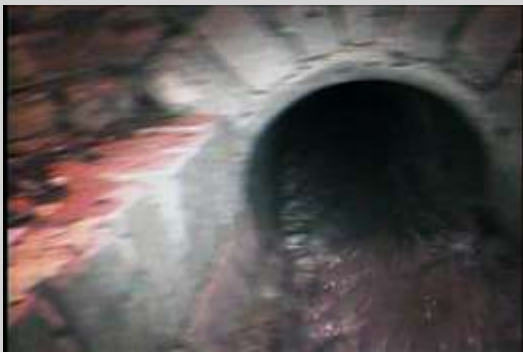
10 in. Circular Gravity Sewer Pipe Out @ 12 O'Clock

Infiltration: **None** Pipe Seal Cond: **Unknown**

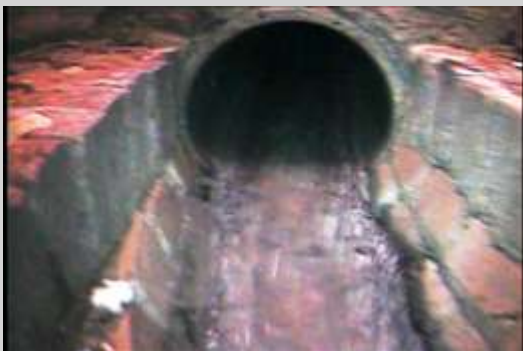
10 in. Circular Gravity Sewer Pipe In @ 7 O'Clock

Channel deterioration.
